# Control Valve Design Greatly Improves Service Life in Pulp & Paper Application

S19L Segmented Ball Control Valve

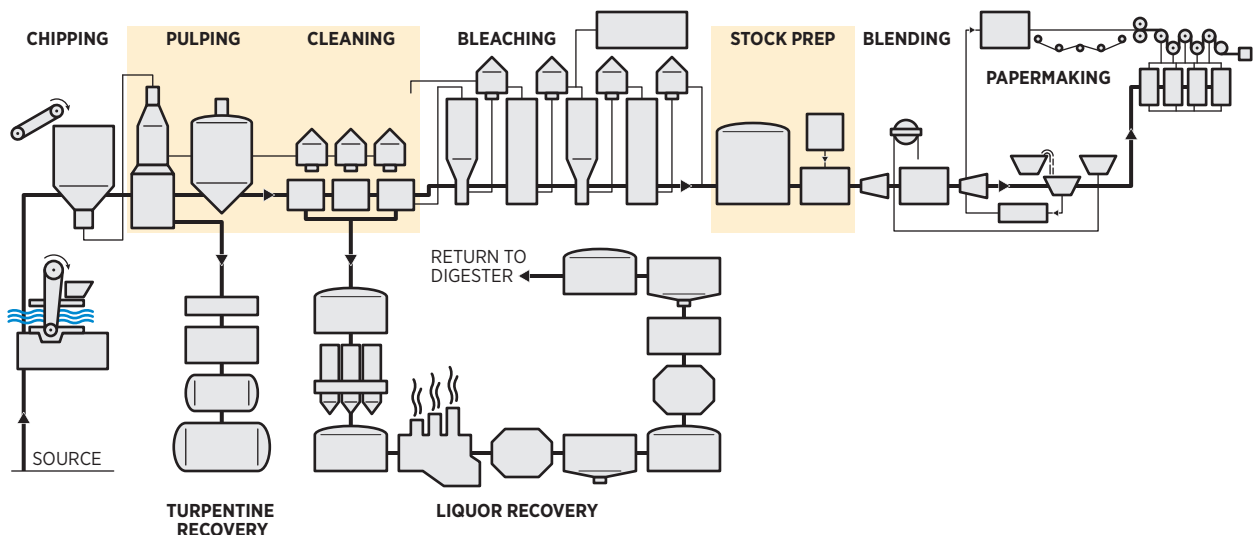
## PULP & PAPER PROCESS

During operation, high-density and forward cleaners are used to separate and remove large, heavy contaminants — such as glass, metal, and sand. A screen system is also used to supplement the cleaners by removing smaller, lighter contaminants — such as plastics, fiber bundles, waxes, and ink. The recycled media in this process is extremely abrasive. If the valve package is not properly optimized, the abrasive media consistently leads to valve failure caused by body and segment erosion.

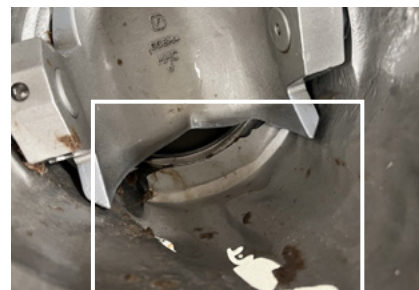
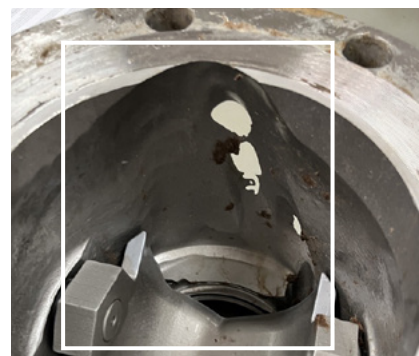
*Inspection of a competitor's failed control valve shows signs of extensive erosion of the body wall, segment, seat, and flange area.*

In this application, control valves were expected to last a minimum of 8 to 12 weeks. However, the competitor control valves were experiencing frequent failures, with a lifespan of 3 to 6 weeks. Abrasive media was causing erosion of the body wall, segment, and flange. These failures were resulting in extended periods of downtime, loss of production, and valve replacement costs.

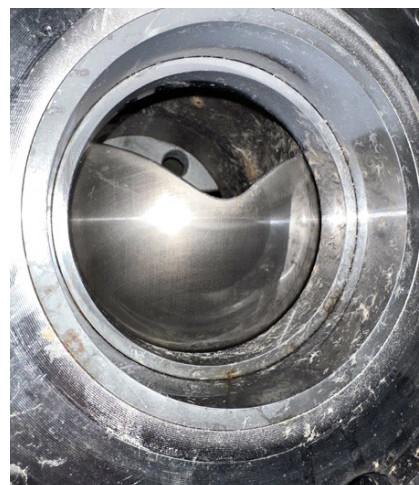
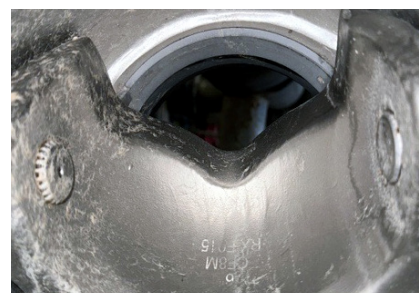
*After 24 months in service, inspection of the S19L showed no signs of erosion on the ball segment, seat, body walls, or liner.*

The recommended S19L was installed as a trial valve to replace one of Bray's top competitors. Throughout monthly inspections, the valve showed no signs of erosion. After 16 weeks in service, Bray had exceeded the customer's expectations by over 100%. At that point, it was suggested that the valve's seat and soft goods be replaced to extend the product's lifespan.

After routine maintenance, the valve was placed back in service, and has performed continuously for **24+ months with zero leakage**. During a 24-month period, the plant has saved over **\$54,000** in valve material costs alone, by switching to the Series 19L Segmented Ball Control Valve.

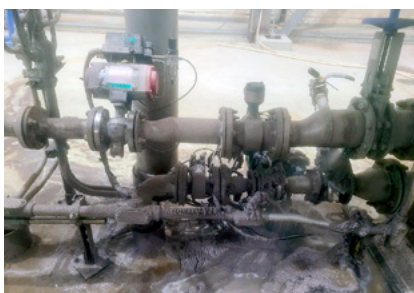
*Bray's Series 19L has performed continuously in the harsh operating environment for more than 24 months.*
